## ParaDyme v4.0.34389 and GeoSteer v2.0.34390 Firmware Release Notes

Ag Leader is pleased to announce the release of new firmware. Features and improvements in this version are listed below.

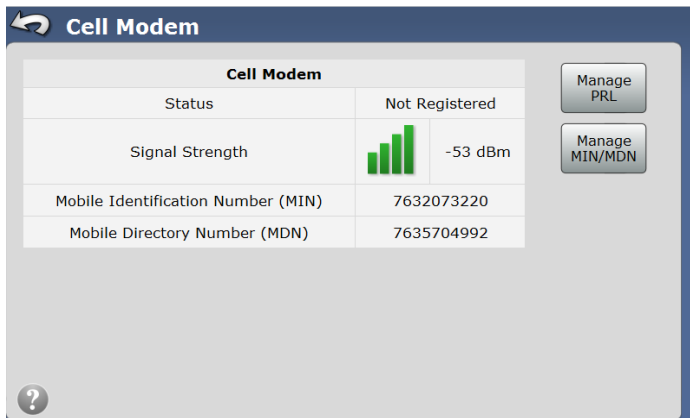
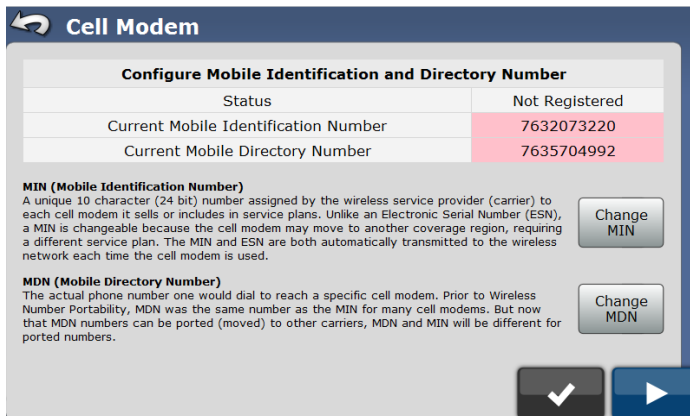
**NOTE:** You must reregister your cell modem BEFORE you reenter the feature codes for RTK ReadyConnect or Remote Service.

**NOTE:** If the Manage MIN/MDN button does not appear and you are certain that your cell modem has been deactivated, then it may be necessary to contact Technical Support for further assistance.

Remote services to all system whose service plan is in EXPIRED state will be deactivated. You can check your cell modem status by going to My Connections > Cell Modem in the setup menu. Technical Support can provide complete documentation for reactivating your cell modem
